Intel® Atom™ Processor N2000 and D2000 Series

Specification Update

March 2012

Revision 007

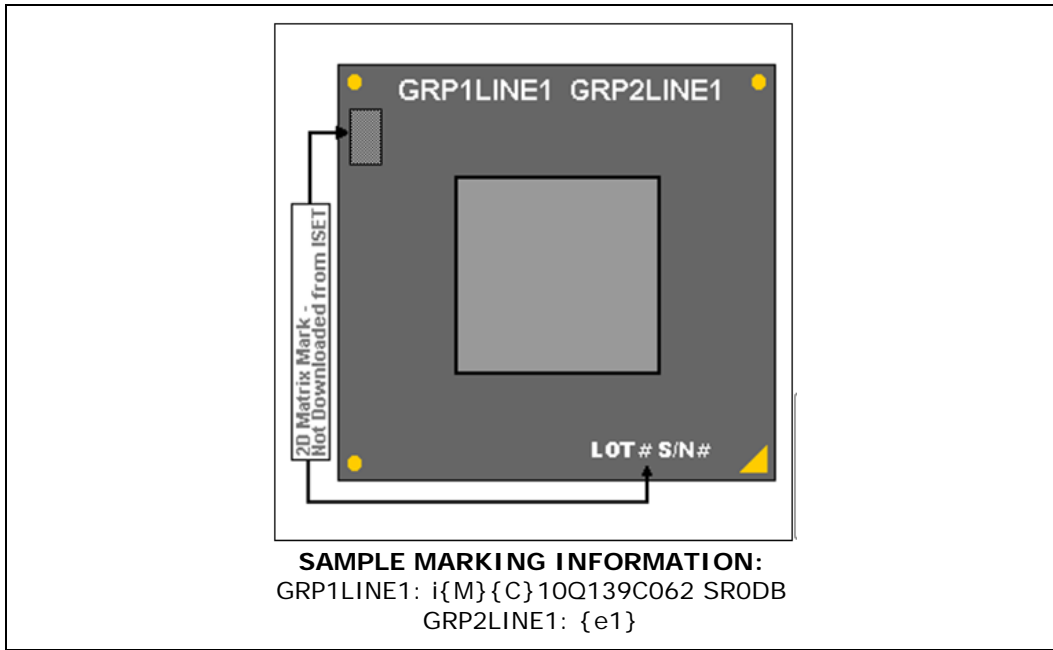
Figure 1: Intel® Atom™ Processor N2000 and D2000 Series (Micro-FCBGA11) Markings

Intel® Atom™ Processor N2000 and D2000 series is identified by the following component markings.

Revision	Description	Date
001	<ul style="list-style-type: none">• Initial Release	September 2011
002	<ul style="list-style-type: none">• Updated Figure 1 Marking detail• Added errata BQ5 to BQ10	November 2011
003	<ul style="list-style-type: none">• Added errata BQ11, BQ12 , BQ13 and BQ14	November 2011
004	<ul style="list-style-type: none">• Added N2000 series to title, content and Table 2.• Added errata BQ15 and BQ16• Corrected implication lost in previous version	December 2011
005	<ul style="list-style-type: none">• Updated Table 2 for new SKU information• Updated new errata—BQ17	January 2012
006	<ul style="list-style-type: none">• Updated Table 2 for new SKU information• Updated new errata—BQ18 and BQ19	February 2012
007	<ul style="list-style-type: none">• Updated Table 2 for new SKU information• Added new errata—BQ20 and BQ21	March 2012
