# Intel<sup>®</sup> Atom<sup>™</sup> Processor Z5xx<sup>Δ</sup> Series

## Specification Update

*Intel<sup>®</sup> Atom<sup>™</sup> processor Z550<sup>Δ</sup>, Z540<sup>Δ</sup>, Z530<sup>Δ</sup>, Z520<sup>Δ</sup>, Z515<sup>Δ</sup>,  
Z510<sup>Δ</sup>, and Z500<sup>Δ</sup> on 45-nm process technology*

*Revision 010*

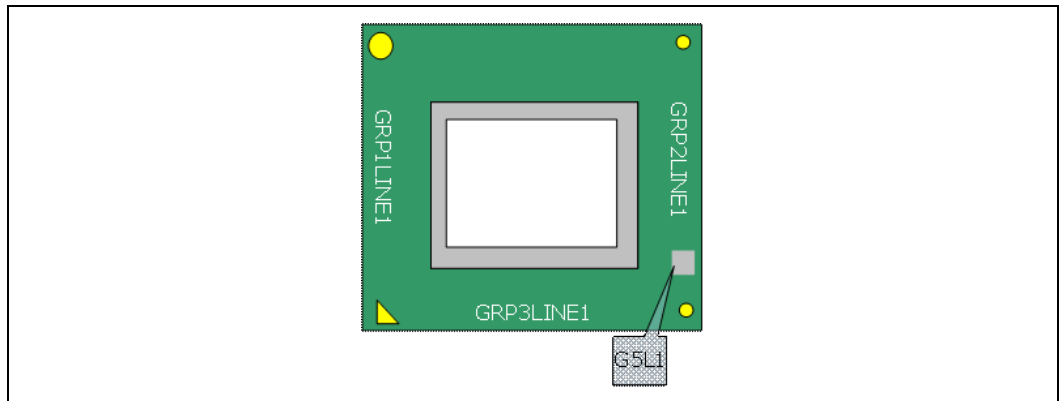
Figure 1. Intel® Atom™ Processor Z5xx Series (Micro-FCBGA) Markings

Intel® Atom™ processor Z5xx series may be identified by the following component markings.

GRP1LINE1: INTEL {M}©'07 {e1}  
GRP2LINE1: <Level-4 Name><FSB>  
GRP3LINE1: {FPO} S-SPEC  
G5L1: 2D Matrix
